VECTOR

POINTING TO SAFER AVIATION

Windshear for the Private Pilot

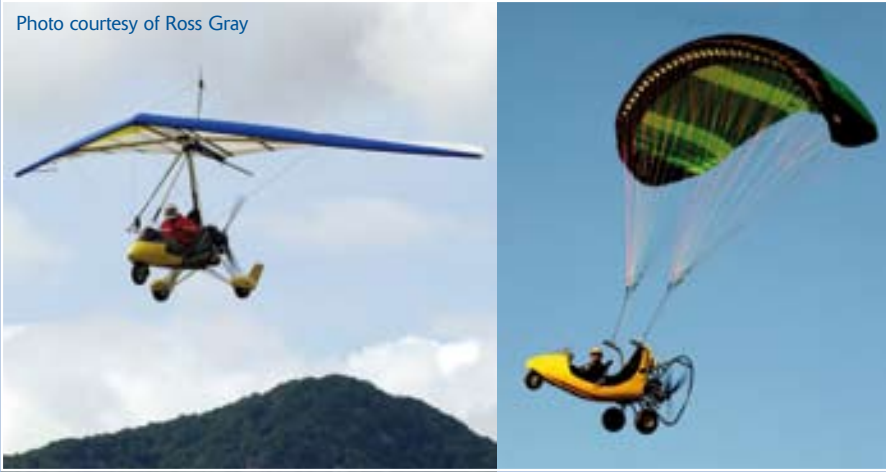
Trikes (left) and powered parachutes (right) are not administered by NZHGPA as they are not foot launched. These are microlight aircraft and are administered by other Part 149 organisations. Rule Parts 103 and 91 apply to them.

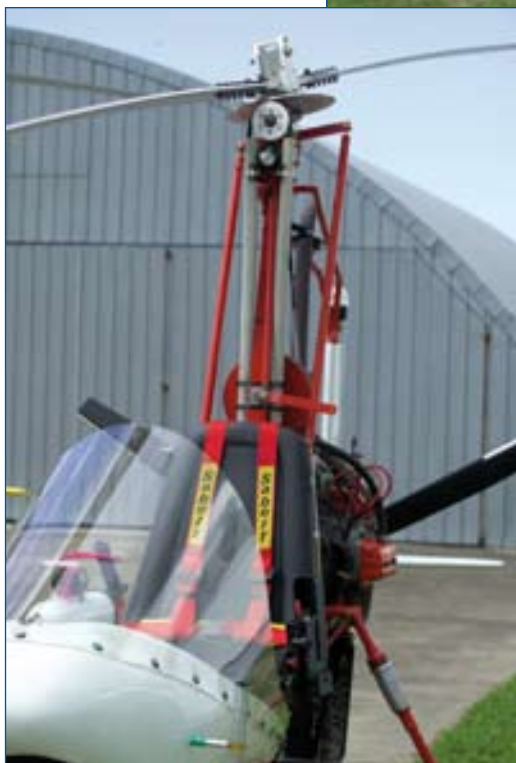
A single seat open cockpit autogyro

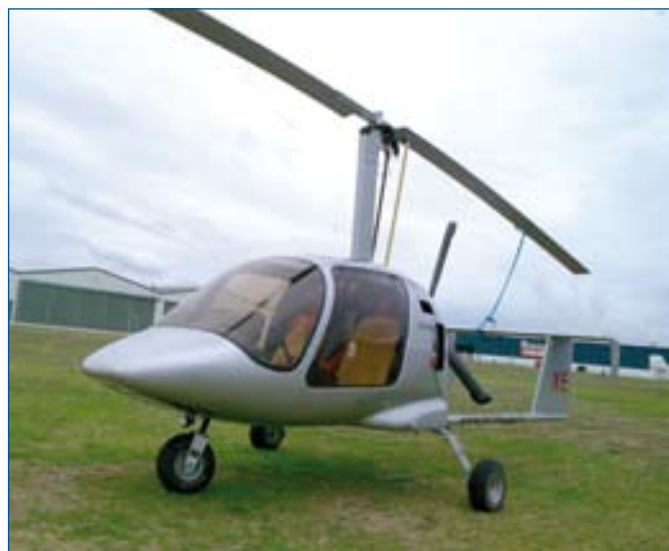
The Xenon autogyro has a fully enclosed cockpit.

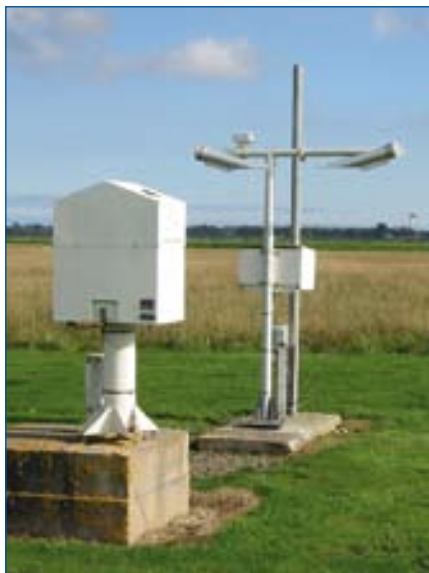
Ceilometer and present weather sensor at Invercargill.

There will be several small differences in the format of AUTO METAR reports, compared with the manual METARs currently produced. These are because the sensors used to determine visibility, present weather, and cloud layers, are unable to scan the sky in the way that a human observer does. "NDV" will appear at the end of each AUTO METAR visibility group to indicate that

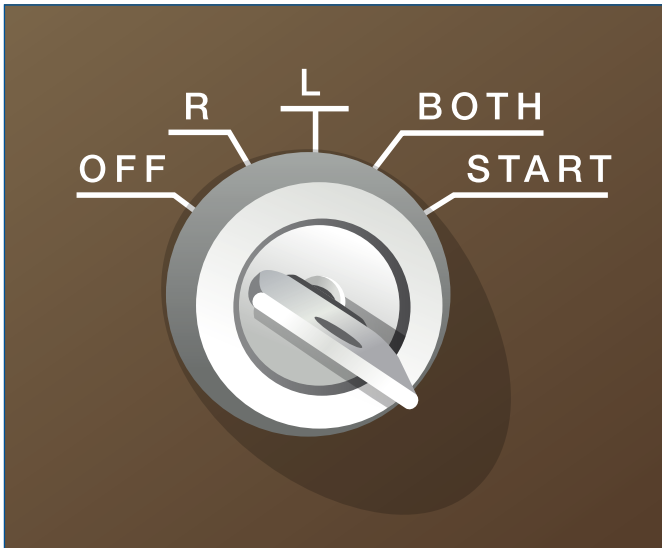
A typical key magneto switch used in many light aircraft.

(In the following discussion, when we refer to a rotary type switch, we assume it to have the layout shown in our illustration of a key-operated switch. The lever-operated switch illustrated, from a Super Cub, has R and L in the opposite sequence, and our comments would need to be transposed.)

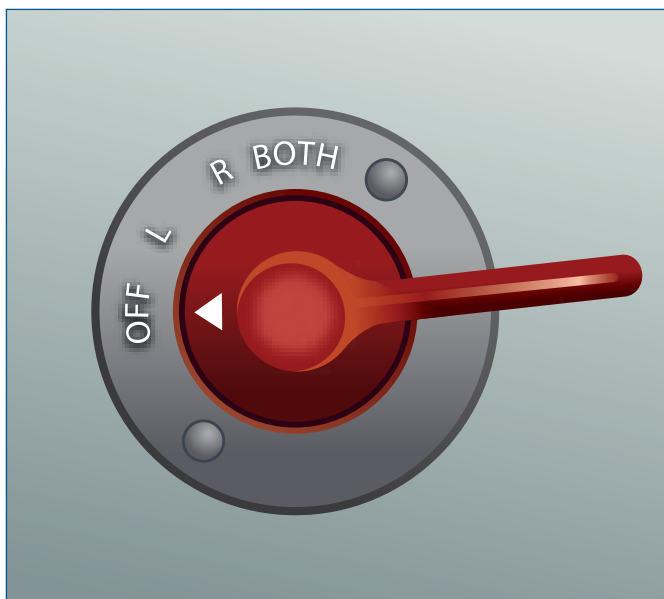
A rotary type magneto switch used in a Piper Super Cub.

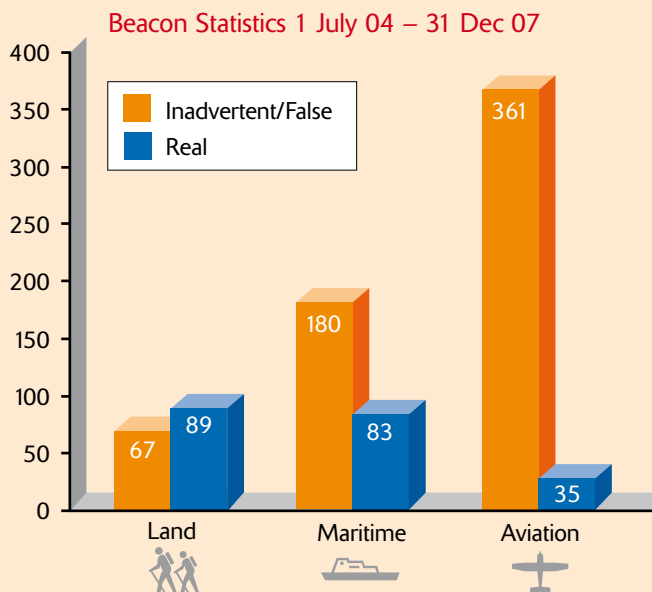
False ELT (Emergency Locator Transmitter) activations waste resources and can divert attention from genuine emergencies. Figures from the Rescue Coordination Centre (RCCNZ) show that aviation is the worst sector for false ELT Activations (see graph).

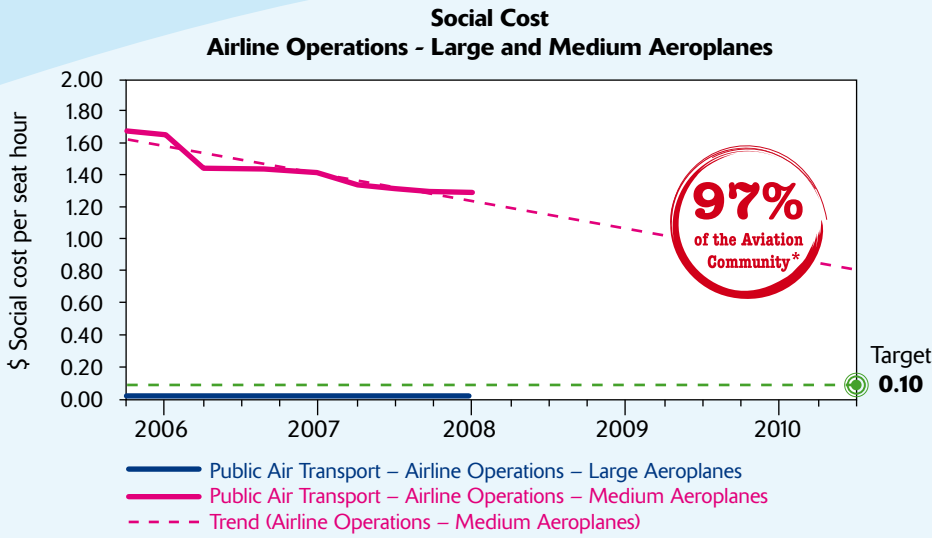
Large aeroplanes are well below their target level of \$0.10 per seat hour. Although trending down, the medium aeroplane sector will not be able to meet the target by 2010. This is because of the relative size of this sector (just 1.3 percent of seat hours). There have been no serious injuries or fatalities involving large and medium aeroplane sectors over the six months to the end of December.

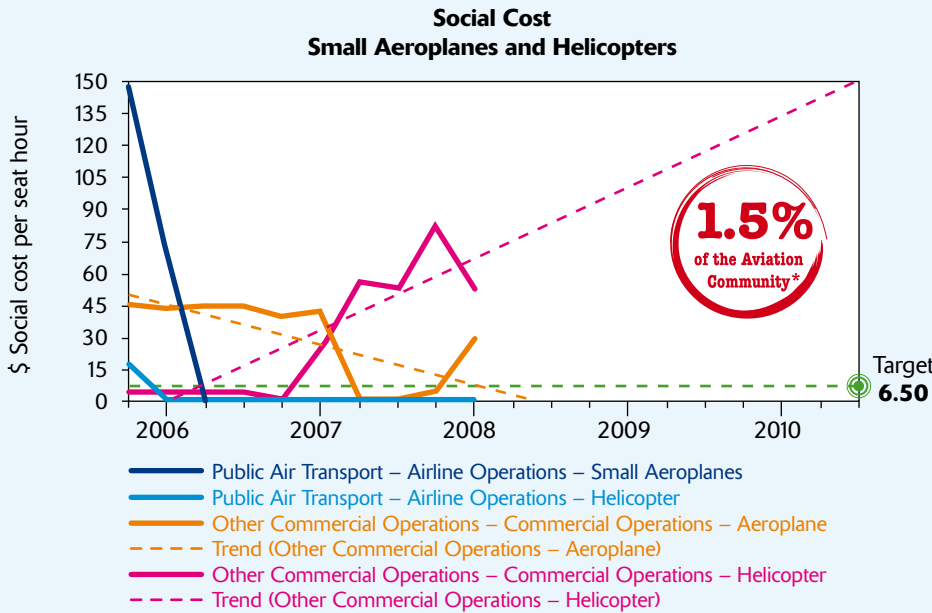
Small aeroplanes used for airline operations are below the target level of \$6.50 per seat hour.

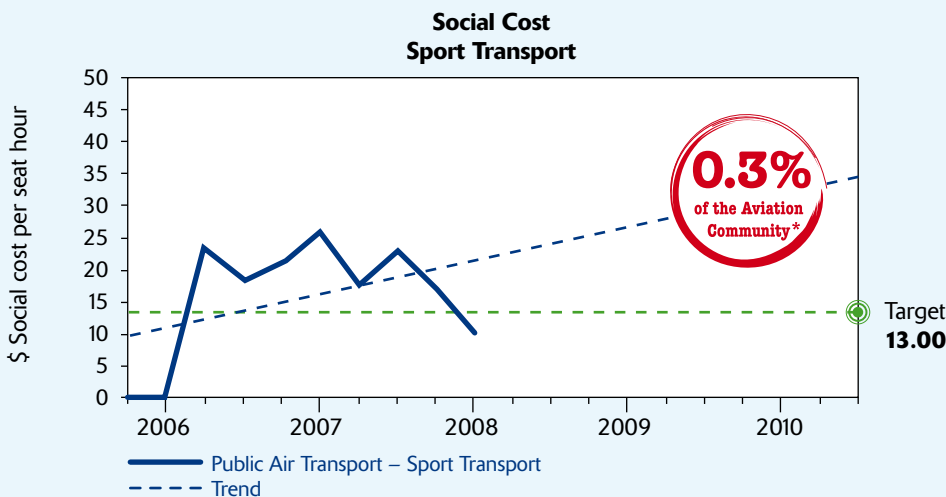
This sector is now below its target level of \$13 per seat hour. There were four serious injuries in this sector in 2007.

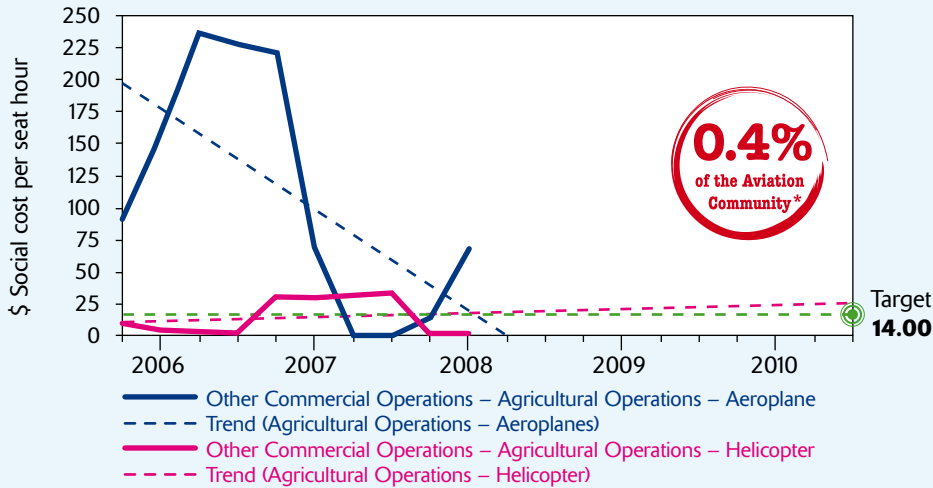
Social Cost Agricultural Operations - Aeroplanes and Helicopters

The sector involving aeroplanes used for agricultural operations now exceeds the target level of \$14 per seat hour following a fatal injury in the last quarter of 2007. There have been no fatalities or serious injuries involving helicopters used for agricultural operations, and this sector is now below the target.

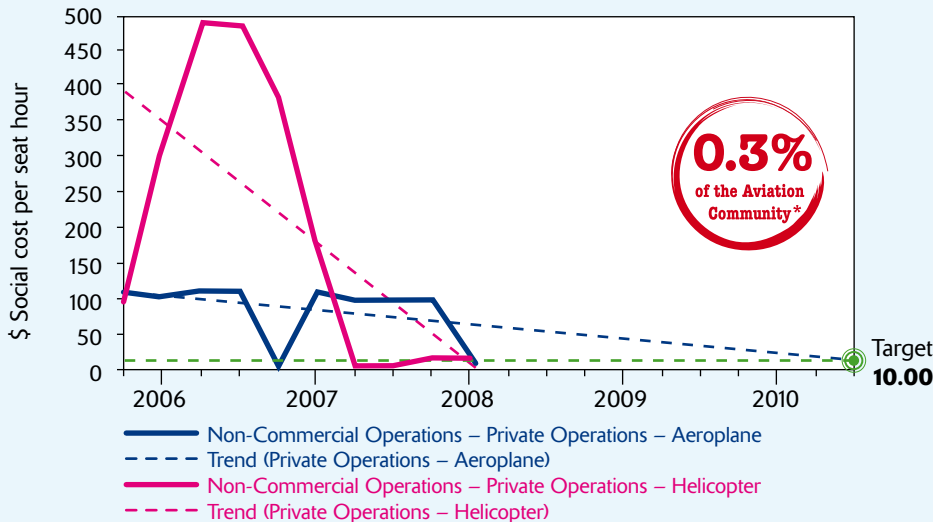
Social Cost Private Operations - Aeroplanes and Helicopters

Aeroplanes used for private operations remain above the target of \$10 per seat hour. Helicopters used for private operations had almost reached the target as at the end of December 2007.
