POINTING TO SAFER AVIATION

vector

May / June 2010

Volcanic Ash	3
Winter Flying	4
Two North, Two South	7
Meet Don Waters	8
Join the CAA Rotary Unit	10
Farewell Foggy	11
Cellphone Use VFR	12
Separation Anxiety	13
What Lies Beneath?	16
Nominations for 2010 Director's Awards and Flight Instructor Award	18
Free Aviation Safety Coordinator Training Course	18
Runway Incursions	19
Marks for Originality	20
Young Eagles News	22
New Products – Mountain Flying DVD	23
Bird Incident Reporting	24
Maintenance Controller Course	24
Rules Poster Update	24
Letter to the Editor	25
GA Flight Examiner Seminar	25
Aviation Safety Advisers	25
How to Get Aviation Publications	25
Planning an Aviation Event?	25
Accident Briefs	26
GA Defects	27
AvKiwi Safety Seminars – Mountain Flying	28

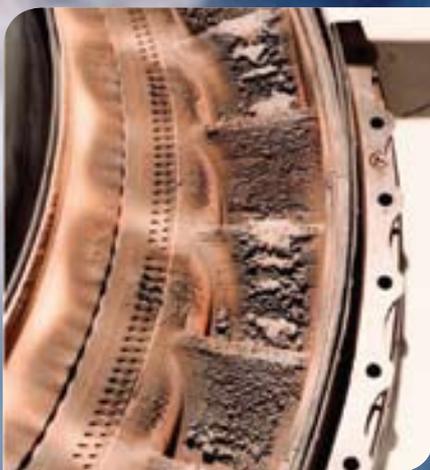
Damage to a turbine from a 747, flight BA009, in June 1982 in which all four engines failed. Photo courtesy of Captain Eric Moody.

There have been many incidents in which volcanic ash has damaged aircraft. The most dramatic is damage to jet engines through wear, impact, and molten silica-type material fusing to the turbine parts (see photo left). But many parts of the aircraft can be damaged, from pitot sensors to fuel systems.

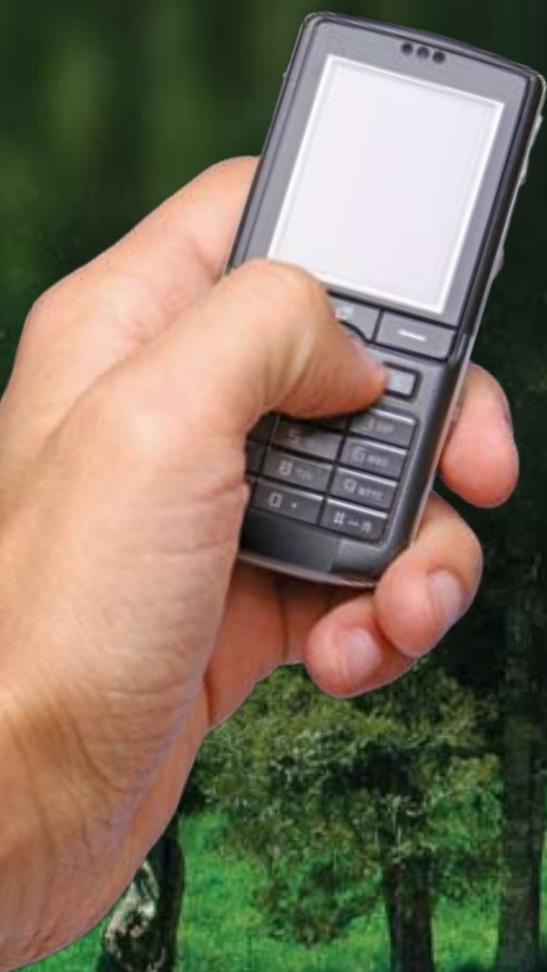
The pilot of this Fletcher was on the phone at the time of the accident. Photo courtesy of TAIC.

On 10 November 2007, a Fletcher FU24-950EX aircraft collided with terrain while top-dressing near Opotiki. The pilot was killed in the accident and the aircraft was destroyed.

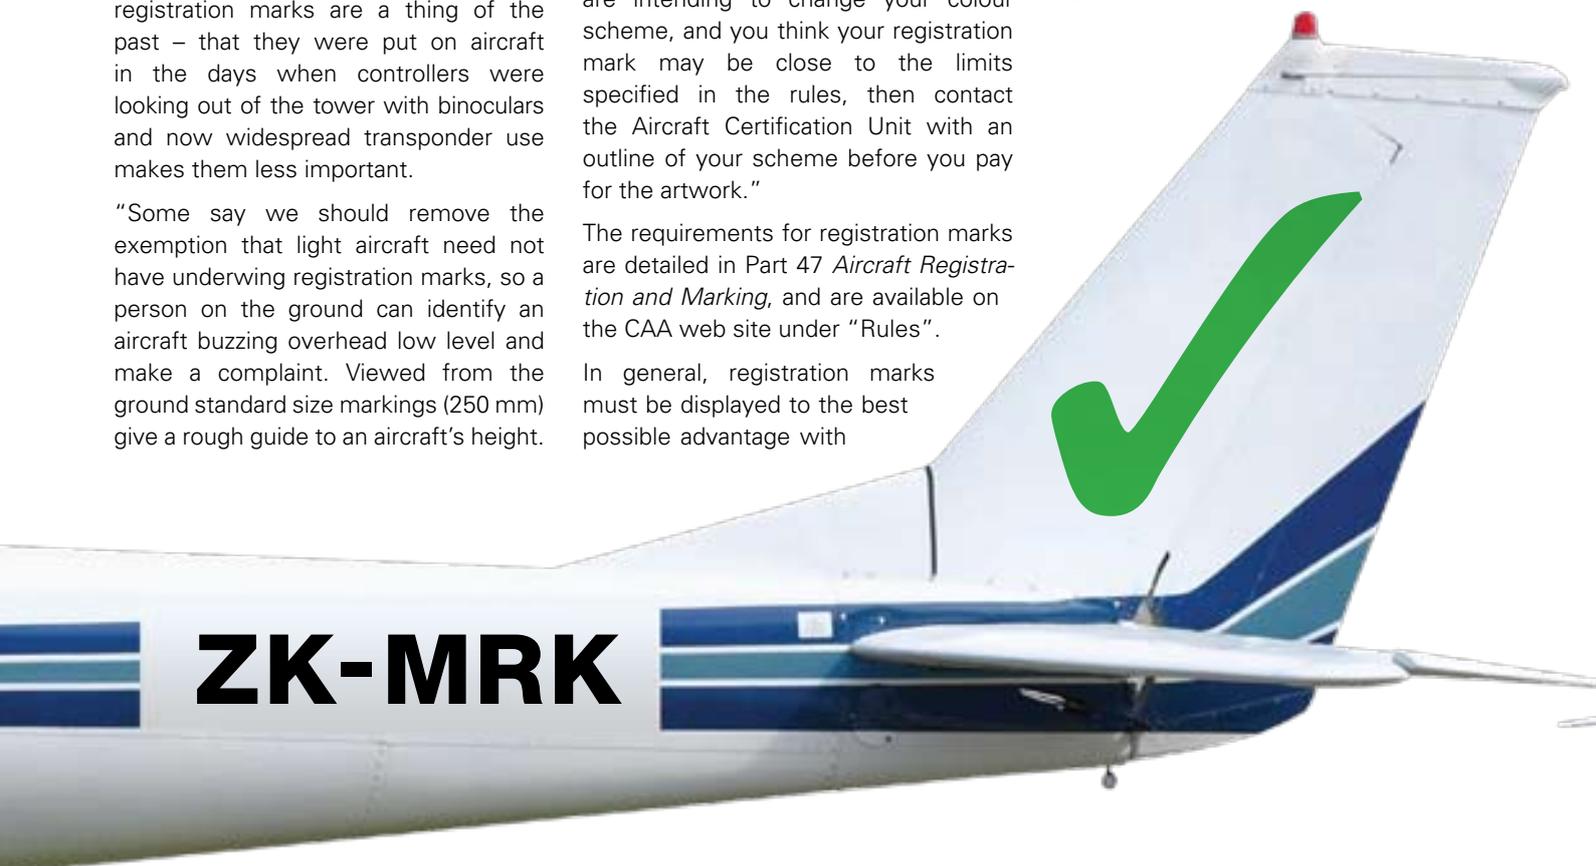
Correct display of registration

Poor displays of registration

Wrapping can make marks difficult to read on tubular shapes such as helicopter and glider tailbooms.

regard to the construction or features of the aircraft, and be of one colour which contrasts clearly against the background colour. Marks must be in capital letters without ornamentation, and the width of all letters (except 'I') must be two-thirds of the height of the letters. The spaces between the letters must be at least one-quarter of the height of the letters. The font must use solid lines and the thickness of the letters should be one-sixth of the height of the letter. The usual height for each letter is at least 250 mm, although approval can be sought for lesser heights where space is an issue. Importantly, no symbol, logo or image can be placed on a mark that in any way obscures it.

The following images are made-up examples of potentially non-compliant registration marks. ■

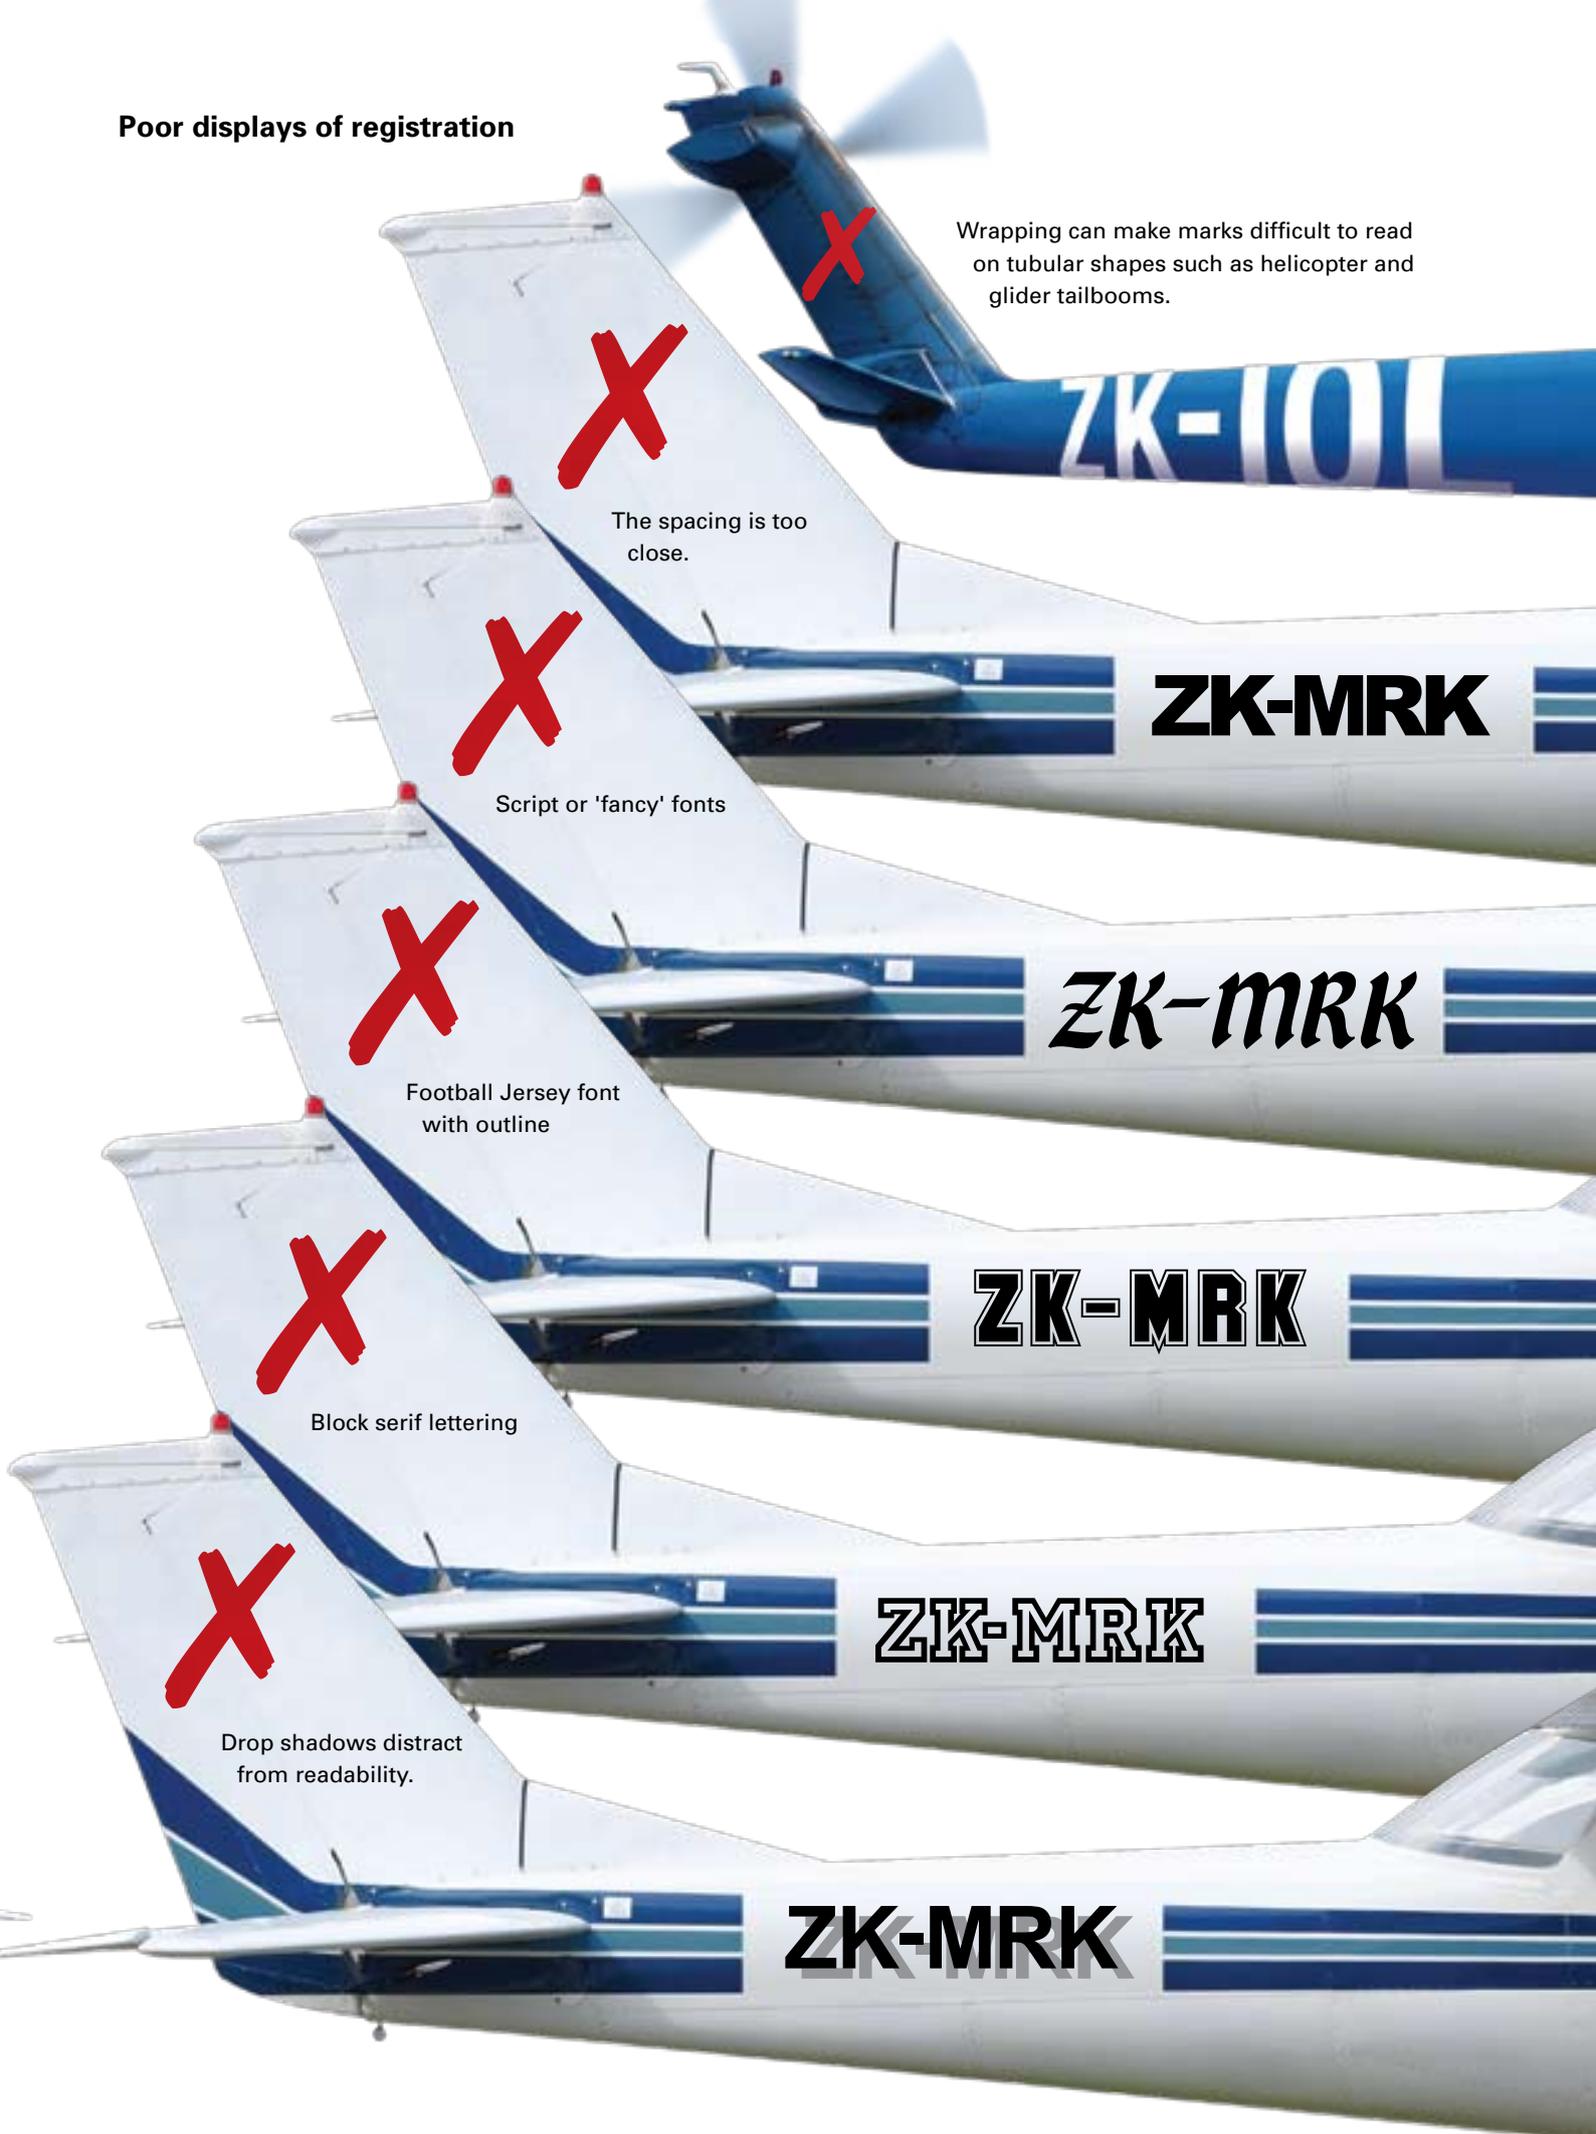
The spacing is too close.
