# Switch it Off and Get Out

# Vector

### Two Belts, No Braces

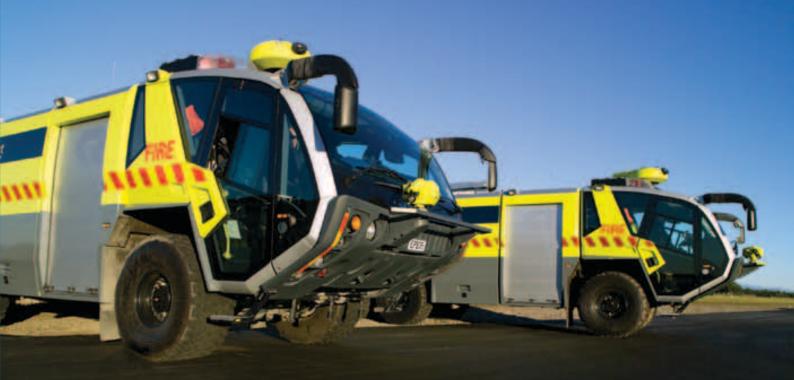
Christchurch International Airport's Rosenbauer Panthers 'Fire 3' and 'Fire 4'.

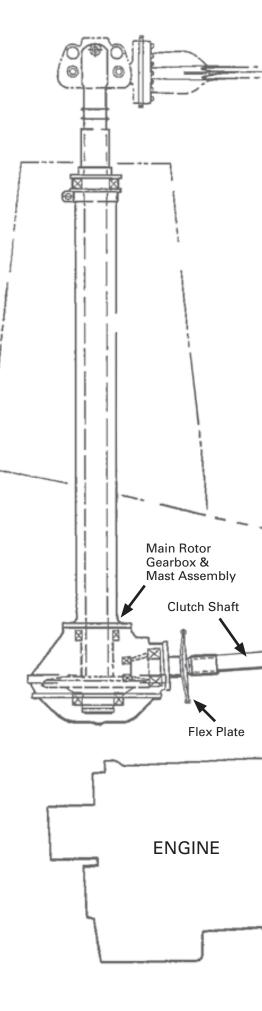
Upper Sheave Incorporating Sprag Clutch V-Belts V-Belts V-Belts Engine Cooling Fan cause damage to both items, with the results not becoming apparent until many flying hours later.

Belt failures do occur from time to time, with results ranging from a destroyed helicopter with fatalities, to a safe landing with no damage or injury. There are two main types of failure – an actual break, or the belts rolling off the sheaves. Breakage can be caused by a preexisting defect in the belt, overstressing through exceeding limitations, or by a foreign object. For example, alternator belts have been known to break and become caught in the drive belts, causing them to fail or roll off. Even dropping a lockwire tail between a belt and the lower sheave could potentially
