# vector

New Flight Instructor Guide	3
Adventure Aviation Takes Off!	4
Busting Wellington	6
Bombing Run Close Call	8
Right Rails – Wrong Station	10
Security Threat Stopped	11
Congestion in Westland National Park	12
Less Search, More Rescue	14
Artex G-switch Update	17
Line Replaceable Unit (LRU)	18
New Authority Member	19
Director to Step Down	19
Keeping Threats and Errors on the Radar	20
Squawk for Safety	21
Bilateral Partners' Meeting	22
CAA Safety DVDs	22
IA Renewal Course	23
National Airspace and Air Navigation Plan	23
Aviation Safety Advisers	23
How to Get Aviation Publications	23
Planning an Aviation Event?	23
Accident Briefs	24
GA Defects	26
Summer Traffic Busy Spots	28

The Communications and Safety Education Unit of the Civil Aviation Authority of New Zealand, PO Box 3555, Wellington 6140.

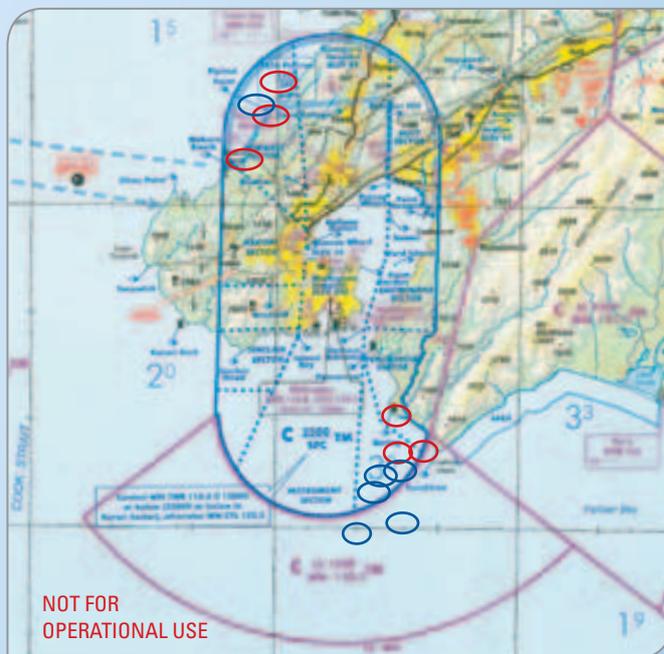
Below: The circles show airspace infringements that are clustered in two hot spots.

“There’s a tendency when transiting from Turakirae Head to Cape Campbell, to cut off the corner of the control zone.

“That area’s important because it’s right next door to the arrival and departure fan for IFR aircraft down to 1500 feet, and it’s also bordered by the instrument sector of the control zone, where jets are descending unrestricted.

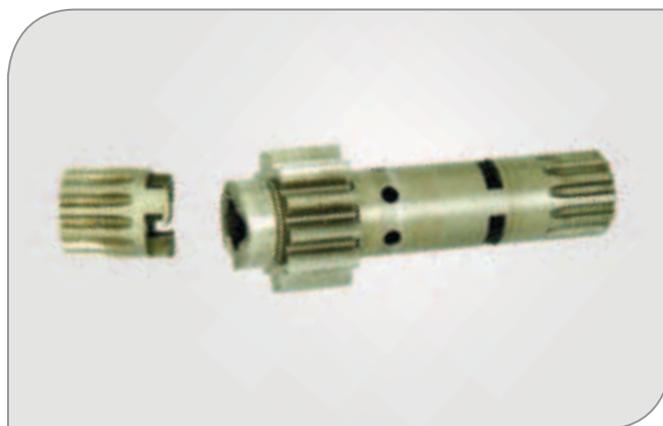
CAA Occurrence Ref 11/617

During takeoff, the aircraft's left engine suffered a significant loss of power. The takeoff was not able to be aborted, so a gradual climb, followed by a landing on the opposite vector was carried out. Maintenance investigation found that the left hand propeller constant speed unit driveshaft had sheared causing the propeller to feather. The governor was sent to an overhaul facility for further

investigation, however, the cause of the driveshaft failure could not be determined.

CAA investigation, in consultation with the manufacturer Ontic Engineering, determined that it was possible that the drive gear was an older version which had a finite life of 4600 hours in accordance with Woodward Service Bulletin 33539C Supplement No.1. The failed drive gear had completed approximately 5770 hours TTIS. Newer drive gears have a service life of four overhaul periods, as specified by Woodward Service Bulletin 33531C. The overhaul period is deemed to be the same as that of the engine to which the governor is fitted.
