vector

The Language Barrier	3
Frost Fighting with Helicopters	7
Runway Excursions	8
Director's Awards 2011	11
Managing Volcanic Ash	12
Just call us 'Paraparam'	14
The Right Bits	16
Helicopter Survey Helps Christchurch	18
Fuel Contamination – a Bug in the System	20
Don't DIY	22
Part 115 Seminars	23
Alcohol Issues	24
Listening Component for English Testing	24
Temporary MOAs	25
ACAG Elections	25
Operations Overseas?	25
Aviation Safety Advisers	25
How to Get Aviation Publications	25
Planning an Aviation Event?	25
Accident Briefs	26
GA Defects	27
Aviation Safety Coordinator Course	28

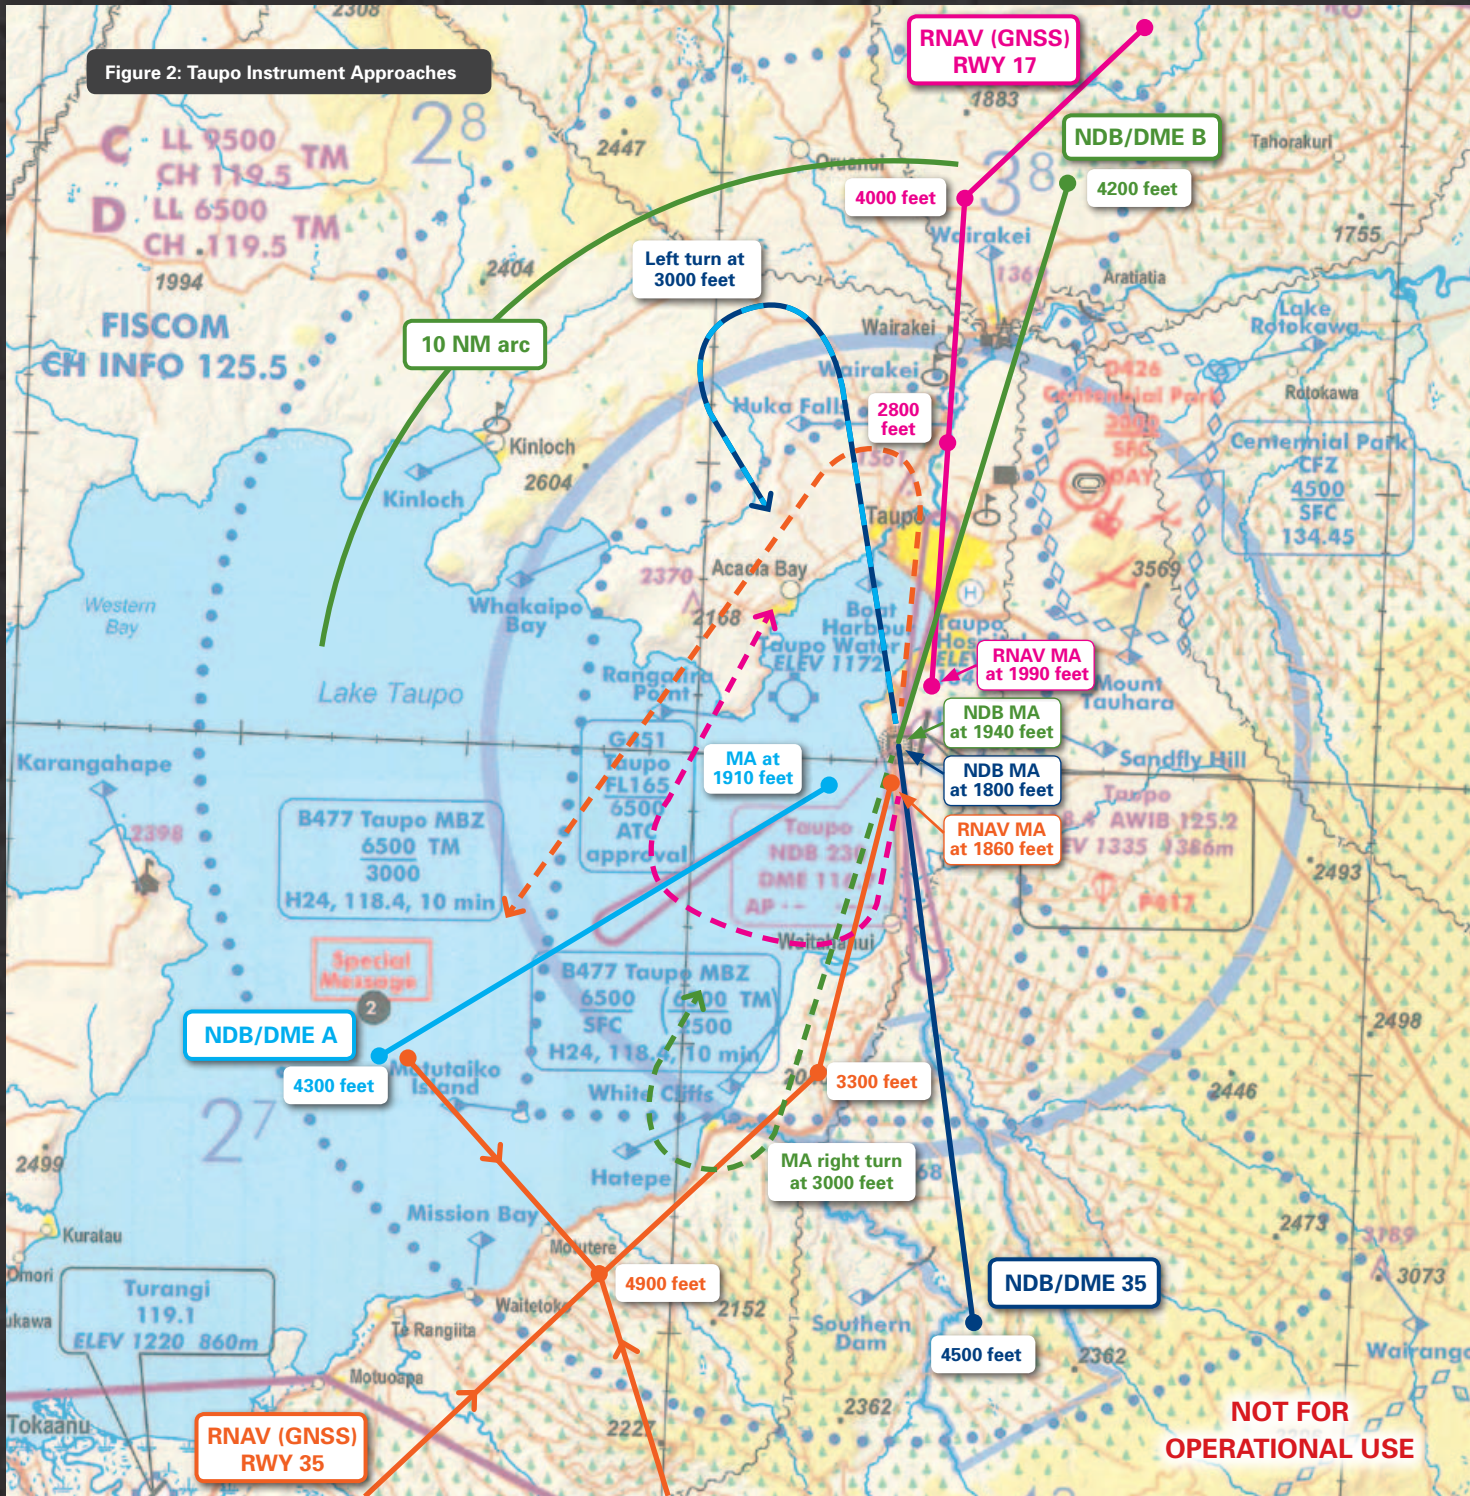
Wanaka

There are two instrument approaches into Wanaka, but their approach and missed approach tracks over the ground are identical. This simplicity makes it easier for VFR pilots to anticipate the movements of IFR traffic. Scheduled operators will almost always fly the RNAV (GNSS) B approach, commencing at KALDI.
