VECTOR

Pointing to Safer Aviation

• **Wake Turbulence** • **Tomahawk** • **Airframe Icing**

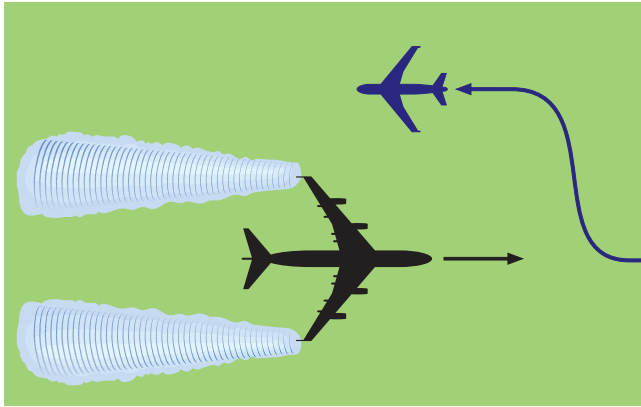
En route

Avoid flight below and behind a larger aircraft's flight path. If a larger aircraft is observed less than 1000 feet above you on the same track (same or opposite direction) adjust your position laterally, preferably upwind.

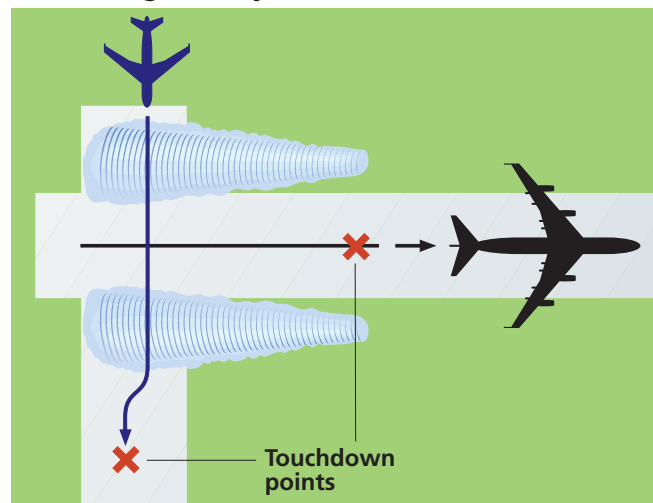
(3) crossing runway

Cross above the larger aircraft's flight path.
